NBS SPECIAL PUBLICATION 601

Implant Retrieval: Material and Biological Analysis

This book contains the proceedings of a conference on implant retrieval and analysis as well as a report on a workshop concerned with implant retrieval systems. Twenty-six invited papers that were presented at the conference are included. Four subject areas are specifically addressed: bulk phenomena, release phenomena, interface phenomena, and information utilization. Implants of both orthopaedic type and cardiovascular type were considered at the conference. Data on the failure modes of implants were presented. Specific consideration of biocompatibility problems was included. Several operating data/information systems were described in detail. Recommendations were made in the workshop concerned with uniformity and standardization of information systems dealing with implant retrieval data.

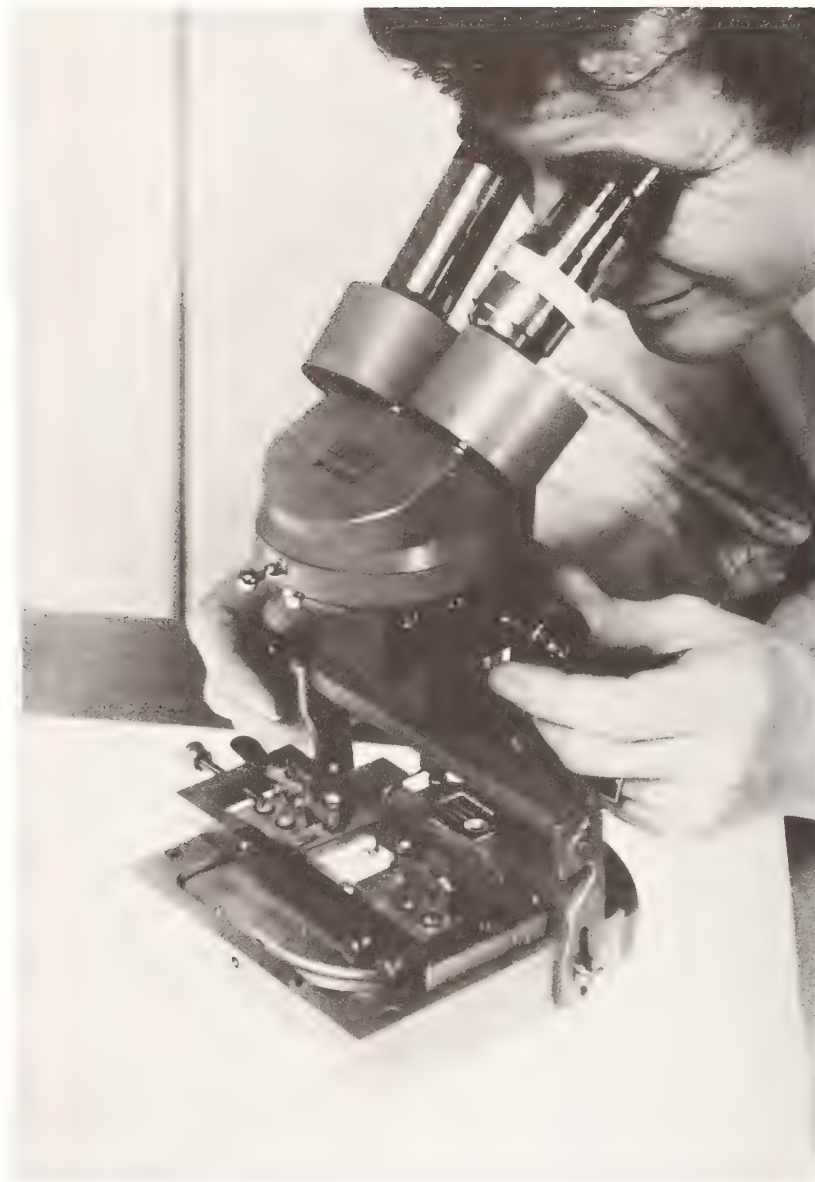
Figure 4 : Measuring the number of courses per centimeter of an explanted prosthesis with the pick counter in transmitted light.

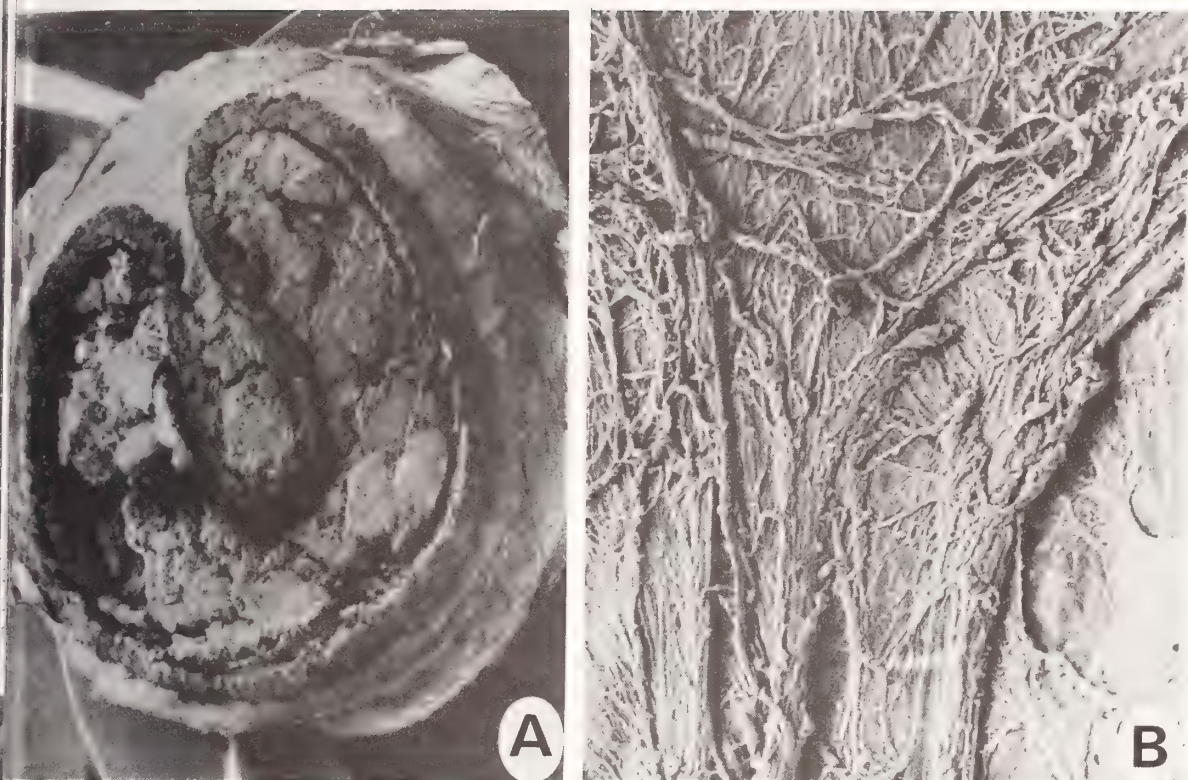
Figure 5.03 : Femoropopliteal graft, 14 months in situ (FP15) totally thrombosed in the distal segment (A:x30) and well healed proximally, SEM surface area shows an orderly layer of compacted fibrin (B:x150).

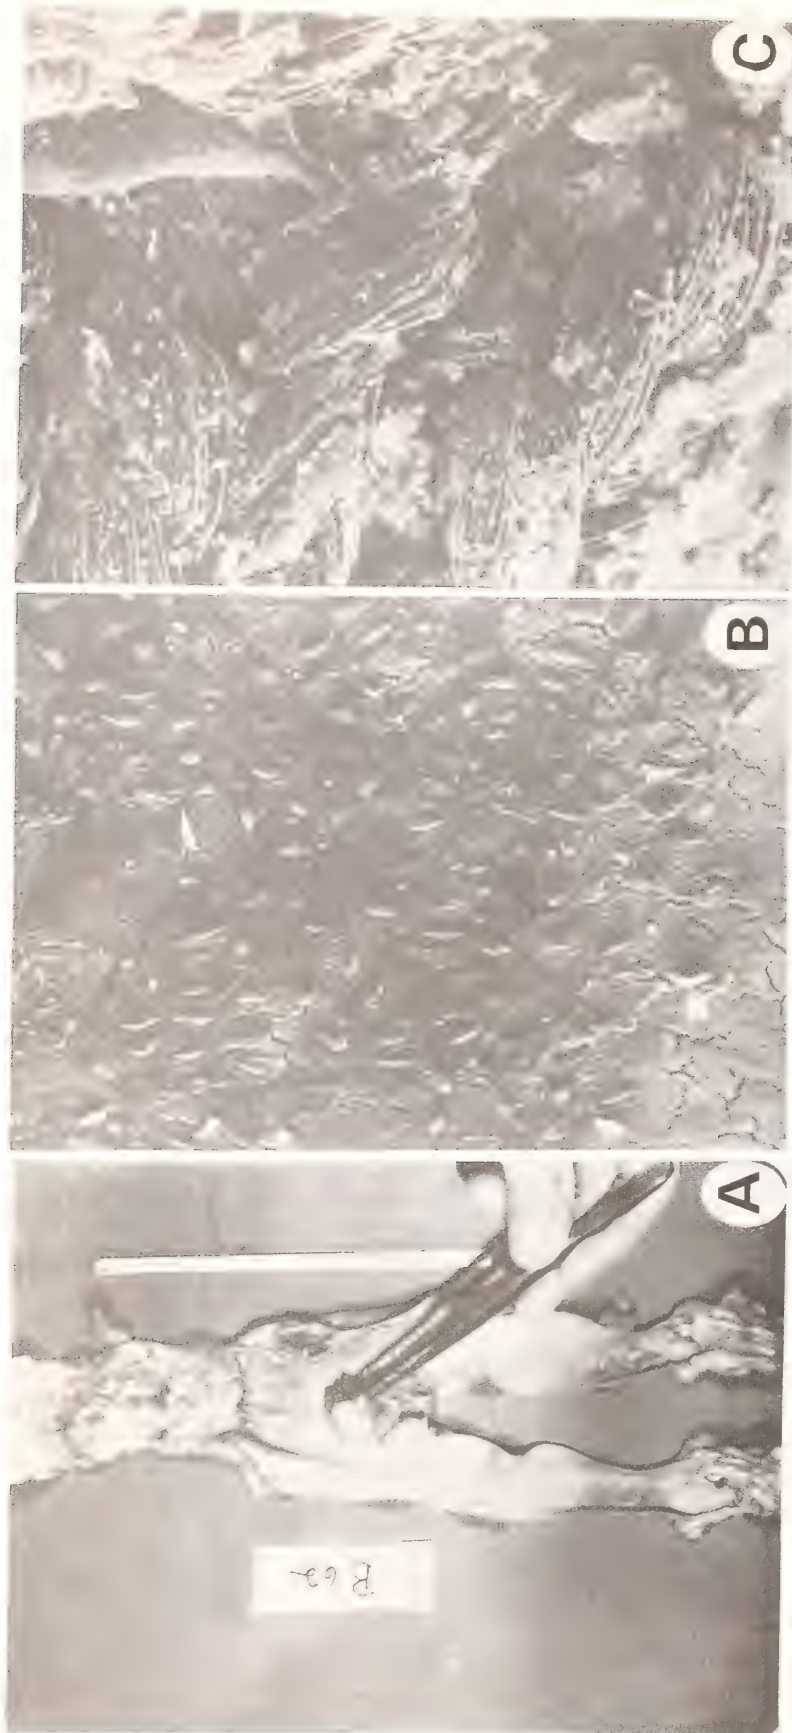
Figure 6.04 : Flow surface of an aorto-femoral bifurcation prosthesis in-situ for 43 months in a 55 years old (Weavenit, B62)
 A: General macroscopic view
 B: Higher magnification showing endothelial-like cells near the anastomoses (x 100)
 C: High magnification showing bare fabric near the bifurcation shelf (x 100)

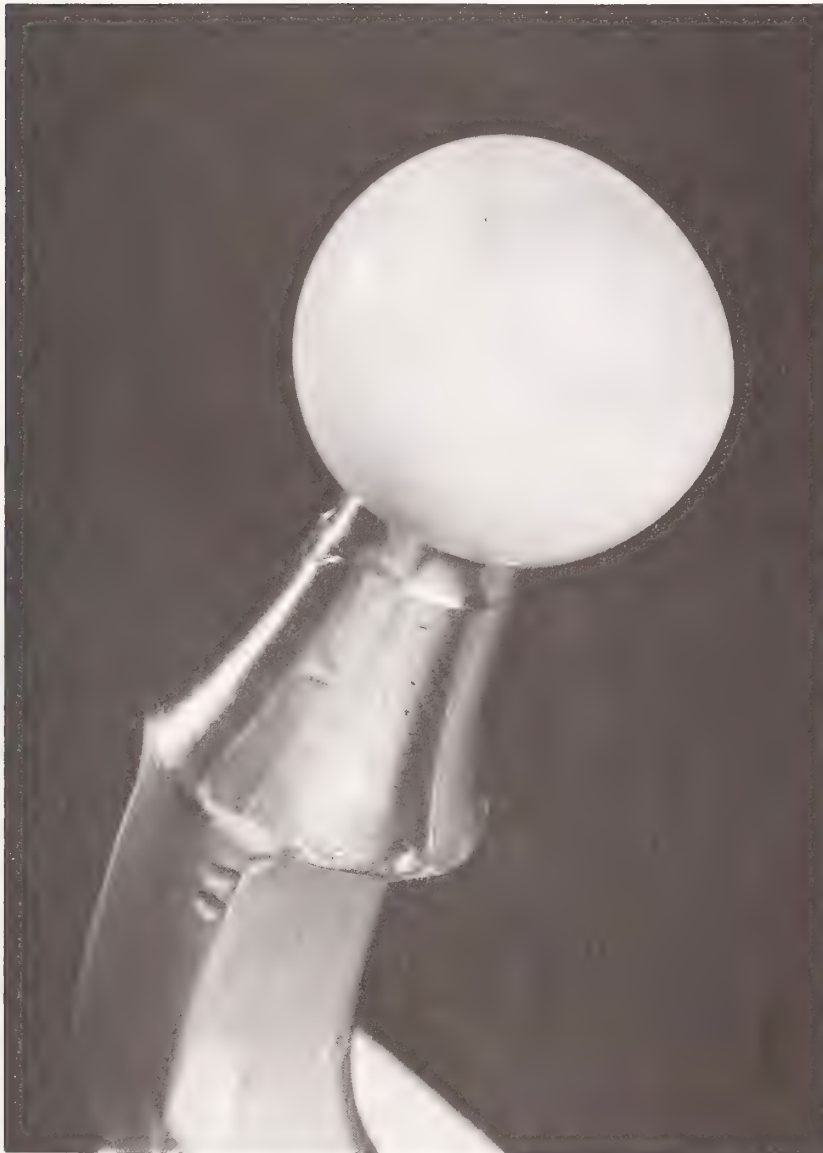
Fig. 8: Removed Al₂O₃-ceramic hip joint prosthesis (implantation period 3 years).

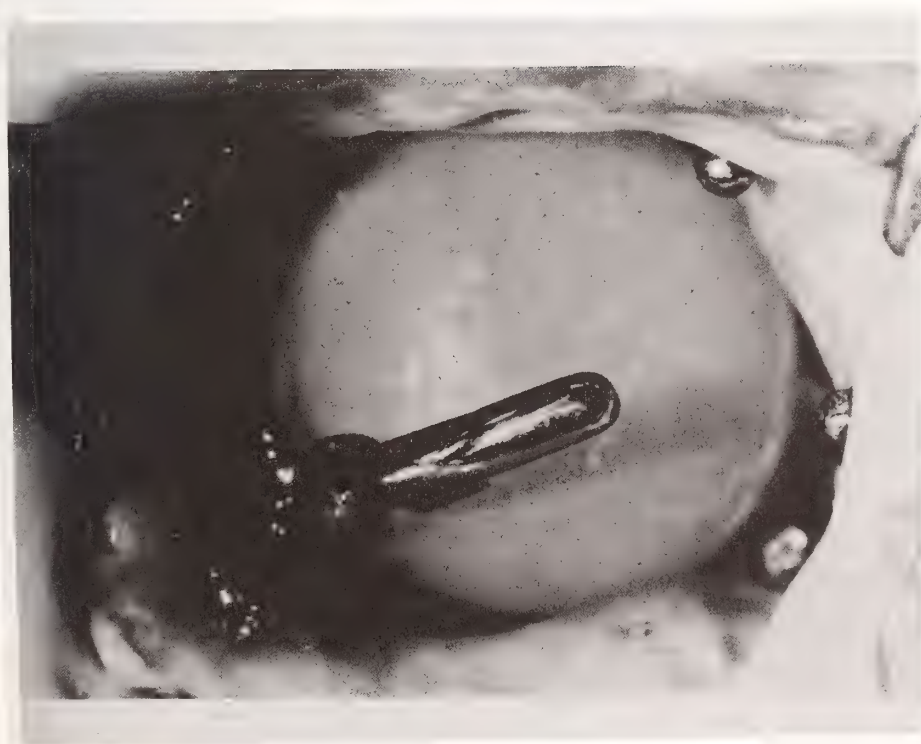
Figure 13. Recovered Smeloff-Cutter ball valve. Thrombus formation at the base of aortic side of the struts.

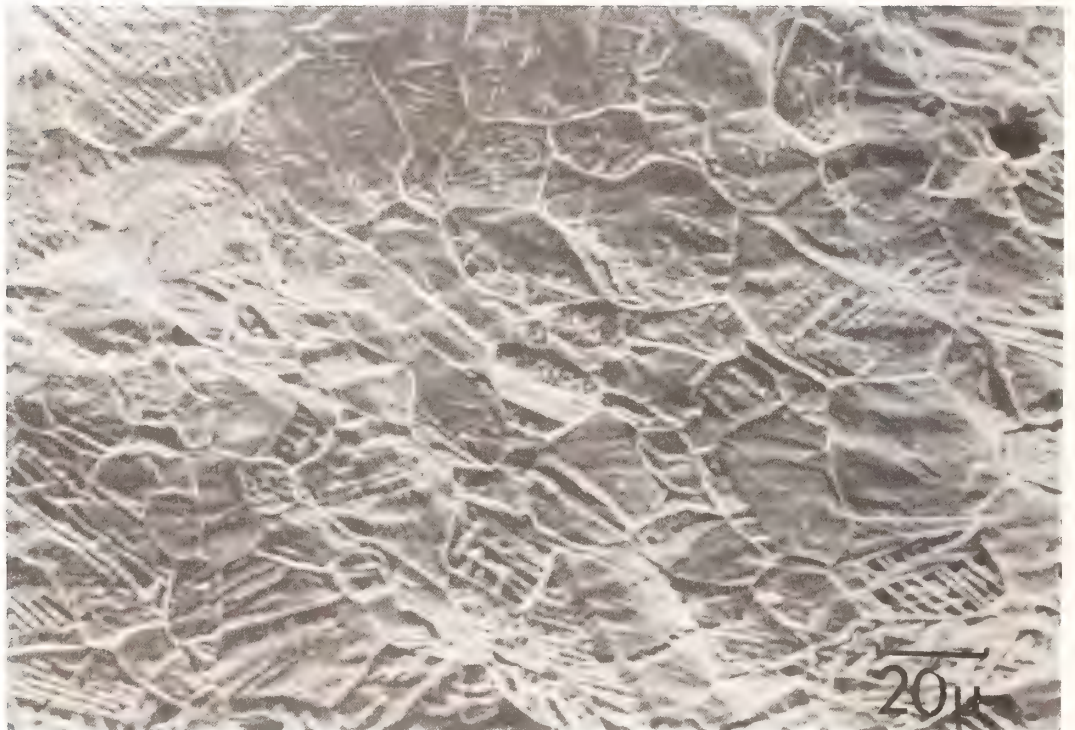
Figure 10. S.E.M. photomicrograph of a screw chamfer showing pitting.

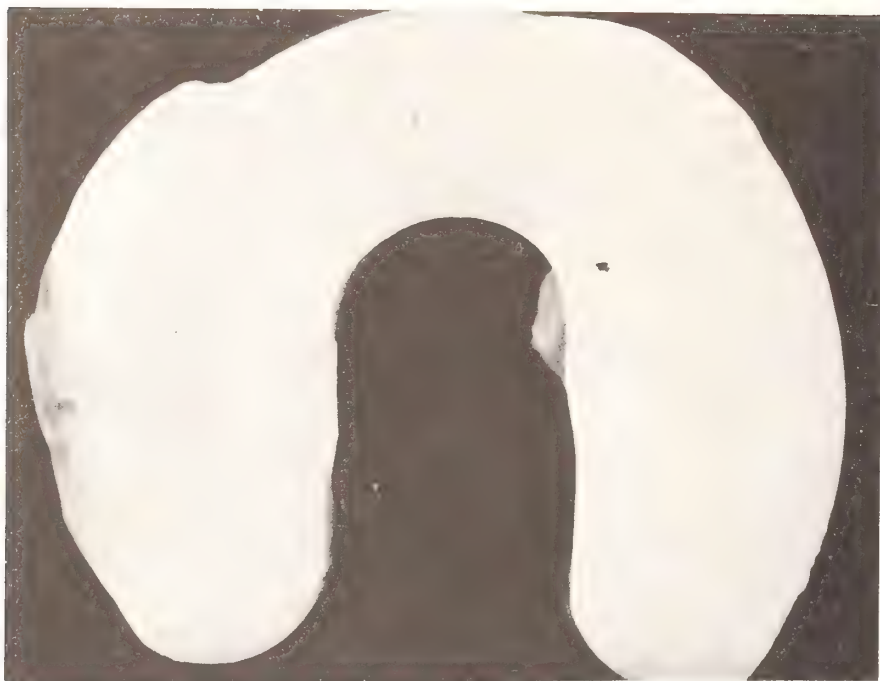
Figure 8: UCI knee component removed after 3 years use.

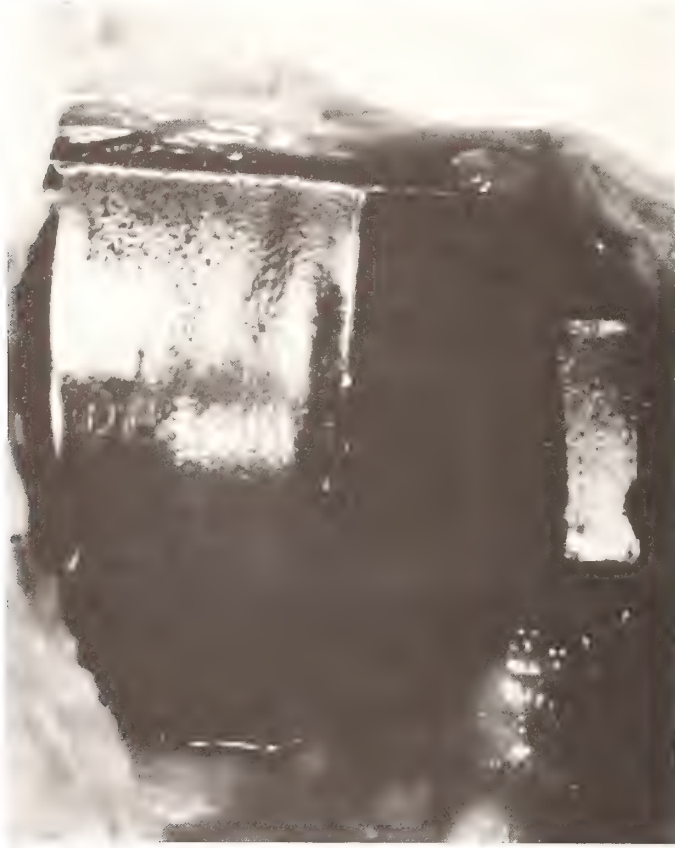
Figure 11: Carbon-fiber reinforced tibial component of Oregon ankle removed after 12 months [30] in the same patient as the component shown in Figure 10.
